# ***Bicycle & Pedestrian Safety Study - Draft***

## **MEMORIAL PARKWAY HUNTSVILLE, ALABAMA**

<b>Client</b>	<b>City of Huntsville</b>
<i>Project</i>	Memorial Parkway Pedestrian Crossing Evaluation
<i>Job Number</i>	3232154
<i>Contract Number</i>	General Services
<i>Client Signature / Date</i>

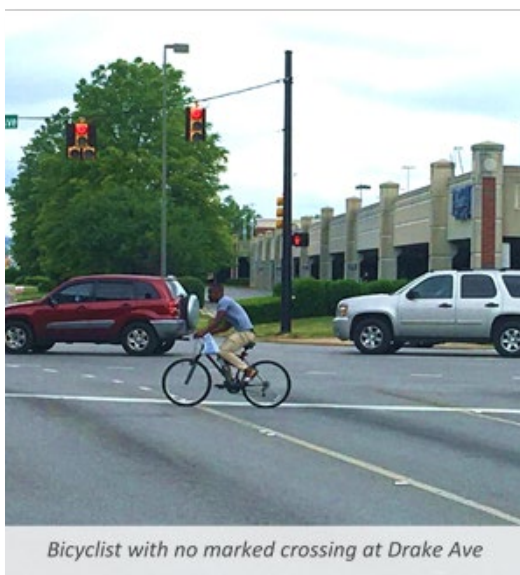
#### Bicycle Level of Stress

The level-of-stress results for the study intersections are shown right. As expected, the majority of Memorial Parkway and intersecting study streets accommodate only Level 4 – Strong and Fearless bicyclists. This is due to the high speed, high volumes of traffic accommodated by these streets, and the limited bicycle facilities available. The exceptions are Logan Drive and Retail Access, which can accommodate Most Adult Cyclists, and the east leg of Meadowbrook Drive, which can accommodate Experienced Cyclists.

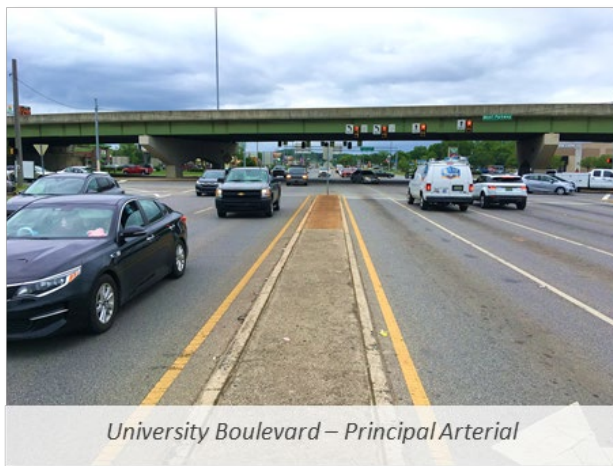
Functional Classification Diagram

As expected, Memorial Parkway is classified as a Principal Arterial, with freeway sections classified as such. Of the study streets intersecting Memorial Parkway, most are classified as major collectors, which distribute traffic to minor collectors and local streets. However, some streets are classified as minor arterials, which connect major arterials and collectors. University Boulevard is the only intersecting street classified as a Principal Arterial.

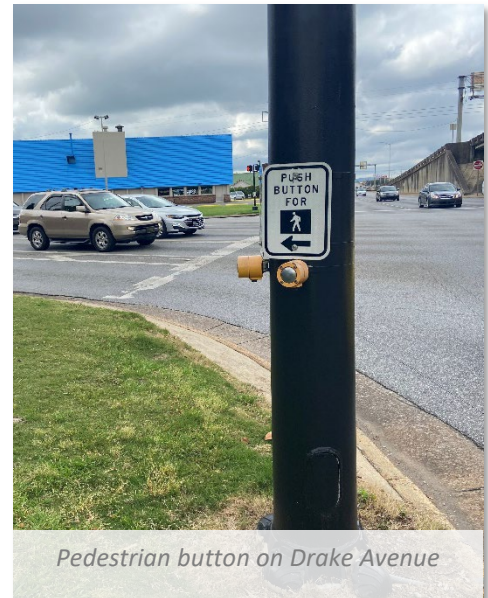
*Pedestrian button on Drake Avenue*

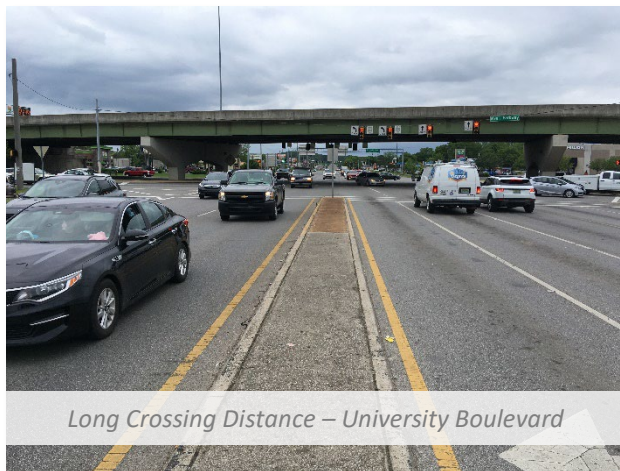
*Long Crossing Distance – University Boulevard*

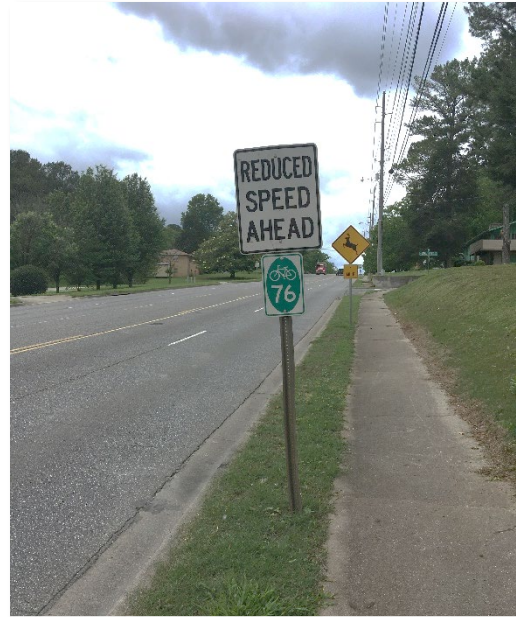
*Bike Route Sign – Winchester Road*

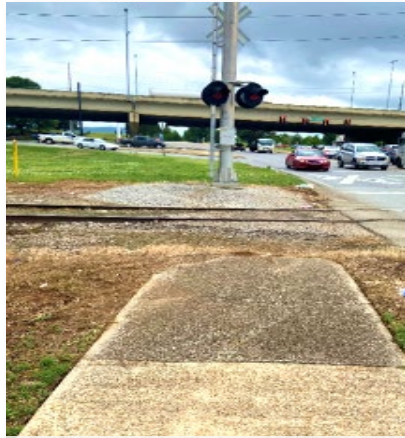
*Sidewalk ends at RR on Airport Rd*

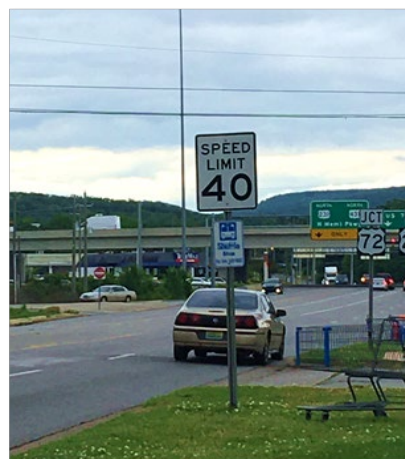
*No Connectivity to Transit Stop  
– Oakwood Avenue*

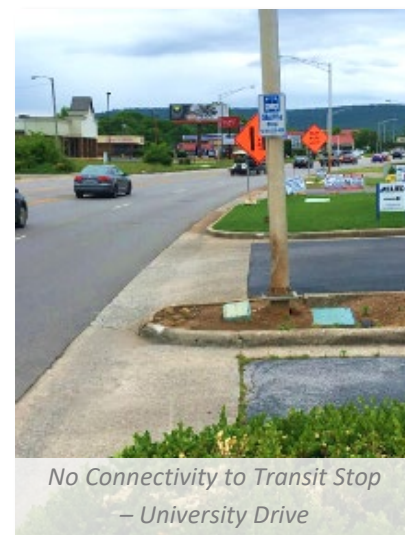
*No Connectivity to Transit Stop  
– University Drive*
